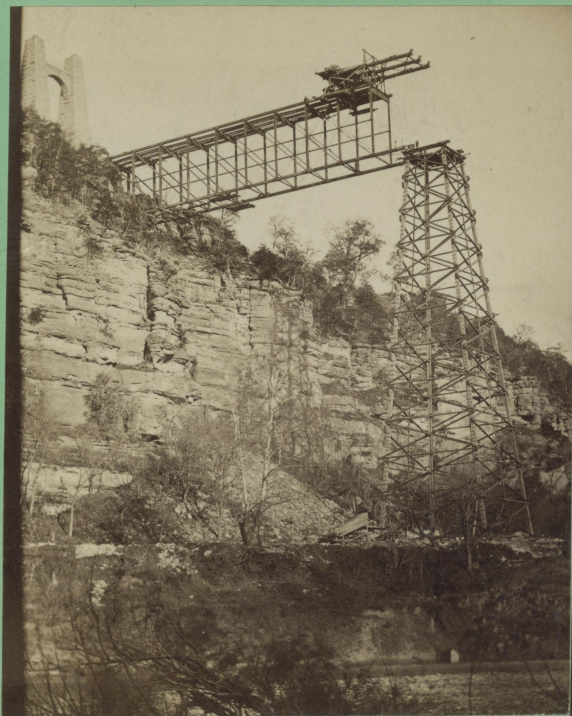
No. 13. Perspective view of Bridge from north side.
