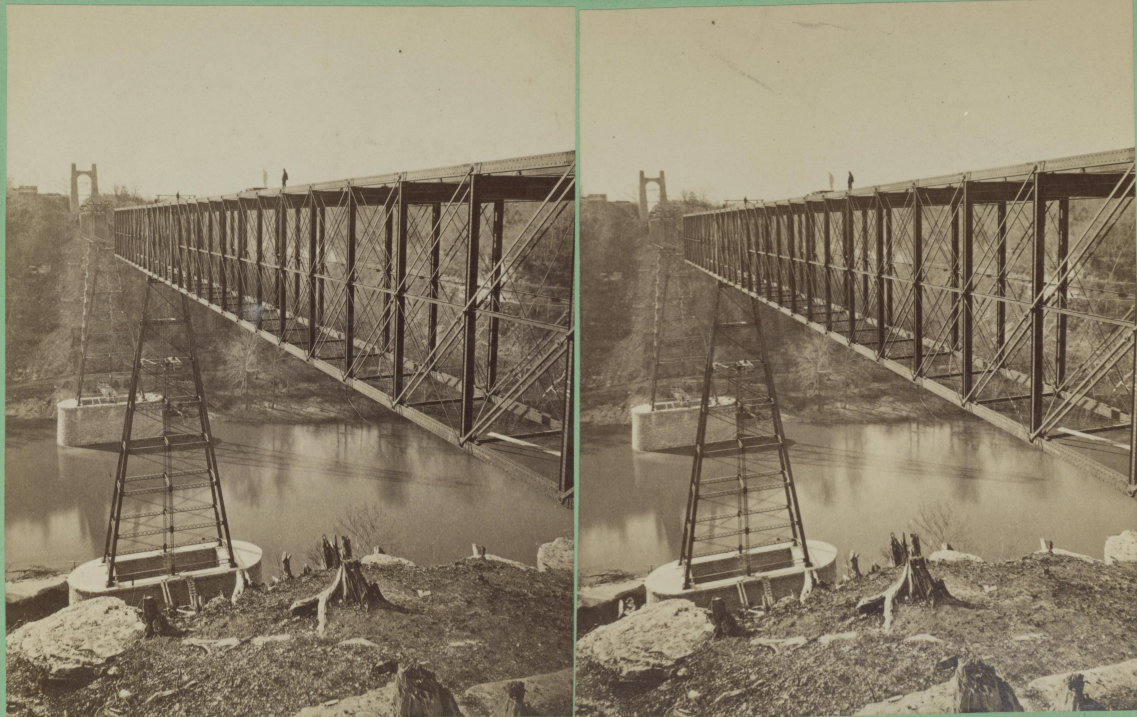
No 13. Perspective view of Bridge from North Side. 23^d Jan. 1877.
