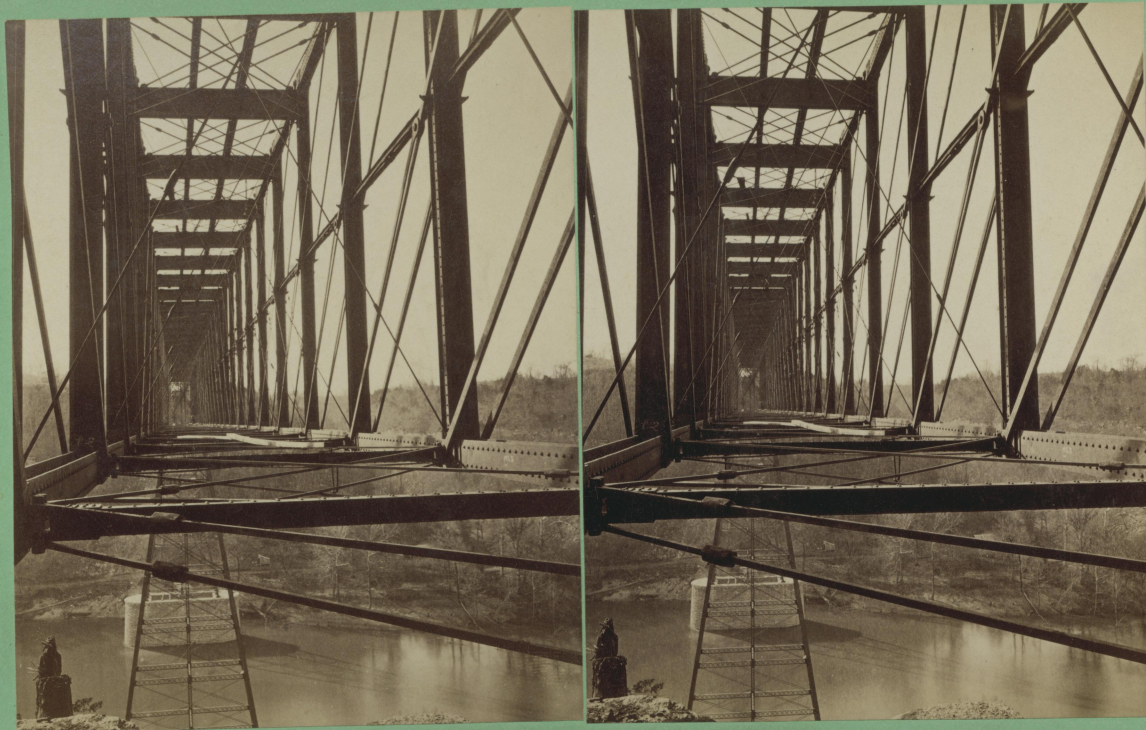
- No. 8. Span No. 1.—Half of Span No. 2 and Pier No. 1.
- No. 9. Span No. 3 (south side) in course of construction.
- No. 10. Half of Bridge (north side) and both Piers.
- No. 11. Perspective view looking through Towers from north side.
- No. 12. Showing progress of construction, January 22, 1877, from mouth of Dix River.
- No. 13. Perspective view of Bridge from north side, January 23, 1877.
- No. 14. Looking through interior of Bridge from north side.
